Treating/Preventing Algae (or Fungi) growth in Tanzania

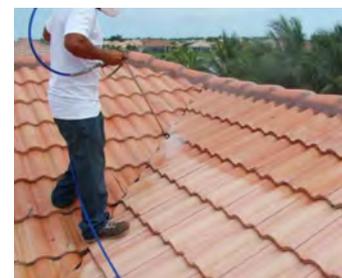
In the dry season this fungi will turn black - this does not mean it is dead - it is in fact hibernating and will turn green again when the rains start

To get rid of this you need to kill/ remove the algae. This can be done by either using a high pressure washer or scrubbing the algae using bleach or chlorine, diluted 1:10 in clean water.

This however is only a short term solution, if the surface remains porous the algae will return.
